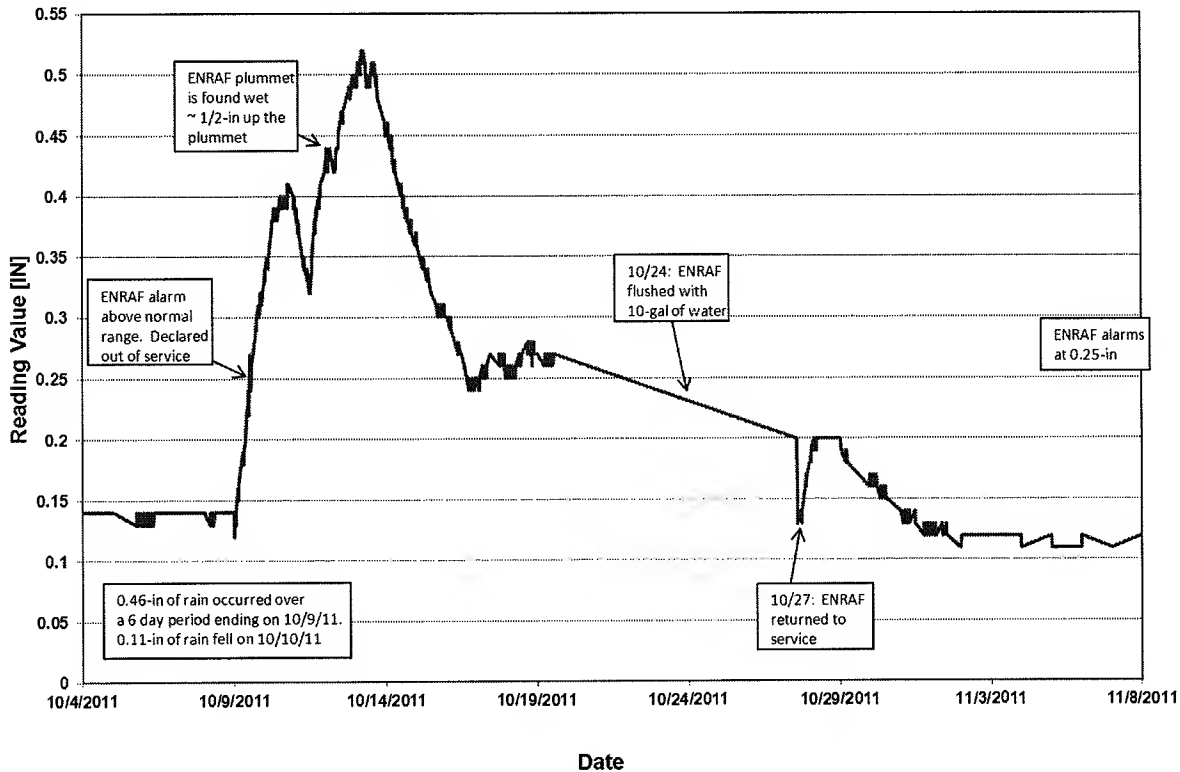
Figure 4-28. Tank AY-102 Riser 90 Annulus ENRAF 152 Liquid Levels October 2011

Beginning on October 9, 2011, ENRAF 152 levels began to slowly increase from 0.26 in. to a maximum value of 0.51 in. on October 13, 2011. Levels then gradually declined to less than 0.25 in. by October 27, 2011. Figure 4-28 shows SDDS data for the October 4, 2011 to November 8, 2011 time period.

Prior to October 9, 2011, 0.46 in of rain occurred over a 6 day period and an additional 0.11 in. of rain fell on October 10, 2011 (Hanford Meteorological Station, October 2011 Monthly Summary). An increase in liquid level and high-level alarm at TMACS occurred on October 9, 2011 for ENRAF 152 (WRPS-PER-2011-2120). On October 12, 2011 it was determined ENRAF 152 was working properly and the plummet was found wet approximately ½ in. up the plummet with a radiation dose rate of 2 – 4 mrem/hr through the sight glass enclosure (see Figure 4-27). Rainwater intrusion was thought to be the cause of the wetness (TOC-ENV-NOT-2011-0012). On October 24, 2011 the ENRAF was again flushed with water. The dose rate on the plummet was 5 mrem/hr before flushing and 1.5 mrem/hr afterwards. As a result of these events, it was recommended that a camera be inserted into the annulus to see if the suspected water intrusion could be pinpointed (WRPS-PER-2011-2120). However, a camera was not inserted into the annulus space until August 2012 (see Sections 4.1.7 and 4.2.6). Table 4-18 provides the chronology of events between the alarm on October 9, 2011 and the ENRAF 152 return to service on October 27, 2011.
